REPORT #E19-308

Condensing Rooftop Unit Field Study: Baseline and Final Report – 2018/2019 Heating Season

Energy 350

Northwest Energy Efficiency Alliance

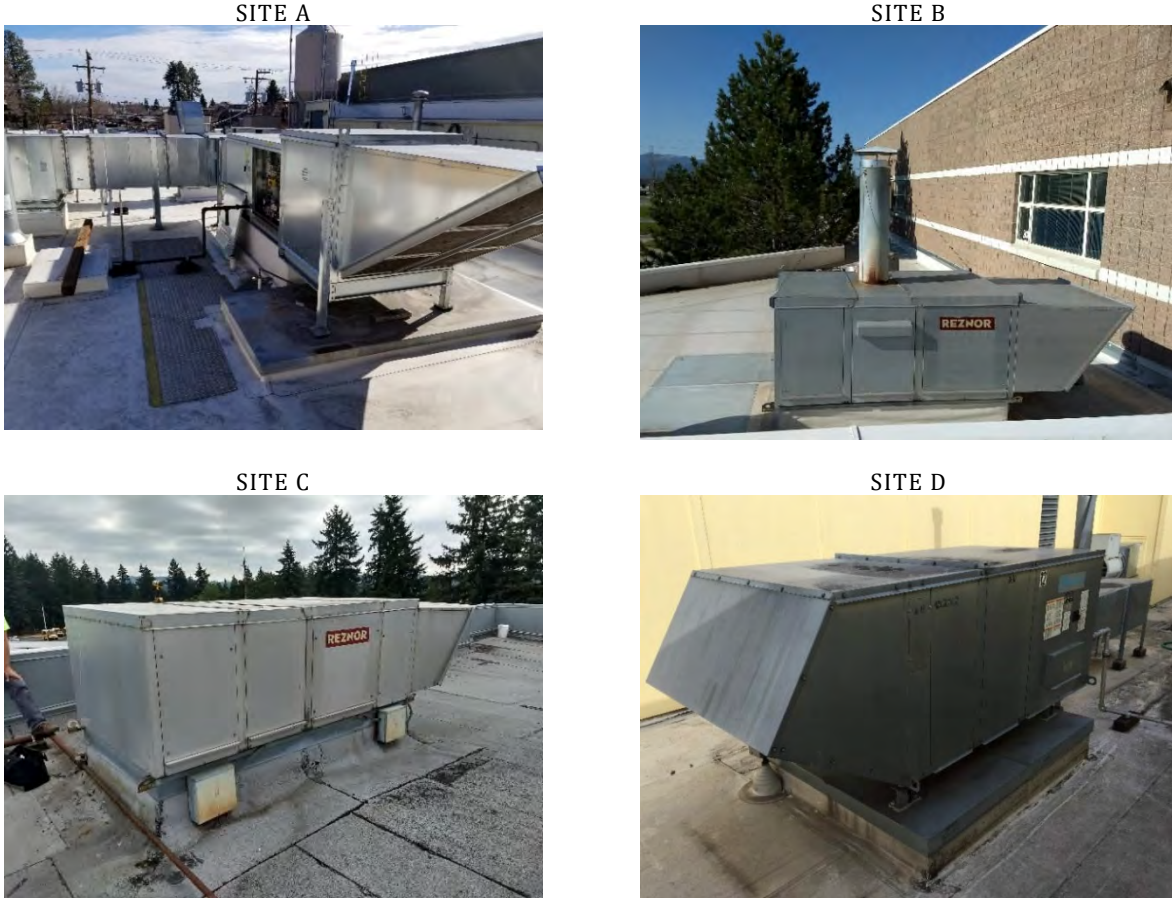
FIGURE 2 – EXISTING RTUS

Additionally, sites were screened based on the structural capacity of the roof to support the much heavier custom units (typically more than 2-3 times the weight of the packaged units being replaced) and access to a nearby drain to dispose of the liquid condensate. Over 15 sites were actively recruited, and many screened out mostly due to structural limitations. A few potential sites were also screened out due to limited access to a nearby floor drain for discharging condensate. The four selected sites are located across three states and two climate zones, and the building types and applications are all unique. Key site characteristics, as well as existing RTU descriptors, are summarized in Table 3 and photos of the baseline RTUs are shown in Figure 2.

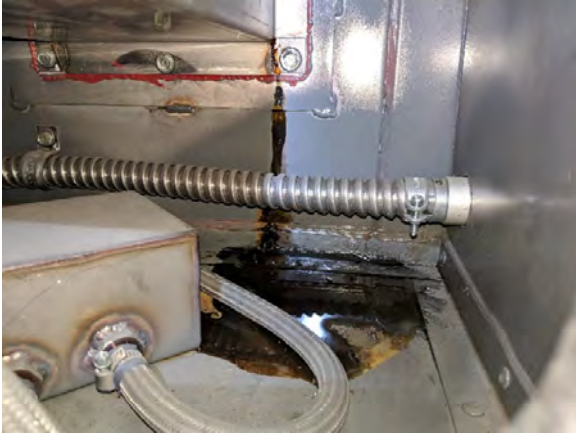
FIGURE 18 – SITE A FLUE BOX LEAK

During a morning equipment inspection, the Site A facility manager noticed a small pool of liquid developing inside the flue cabinet below the flue exhaust. Upon close inspection, he discovered a slow leak from the lower right corner of the box where combustion gases exit the heat exchanger before being exhausted through the flue, as shown in Figure 18. A small amount of this condensate was also leaking around the condensate drain stub (pictured in Figure 19). After consulting ICE Western, Energy 350 removed the flue box to identify the issue and discovered a small gap in the welding joint (Figure 20). The facilities manager had his/her shop repair the weld, and we reattached the flue box and sealed all joints with high temperature sealant. No further issues have been discovered.

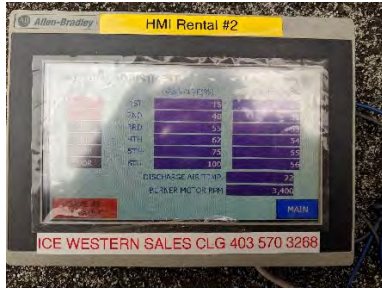
FIGURE 22 - HMI TOOL

Both ICE Western units required additional burner tuning after startup, which was only possible with a special HMI tool (Figure 22) that had to be shipped from the manufacturer. We were unaware of the need for this tool for the installation of the first ICE Western unit (Site A), and we elected not to have ICE Western send a technician from Calgary as the HMI tool was not included with the unit and was quite expensive. However, after the installing contractor's burner technician was sent to Site A to tune the burner, and was unable to do so with the tool, we hired an ICE Western technician to fly down with the HMI tool and tune the burner.

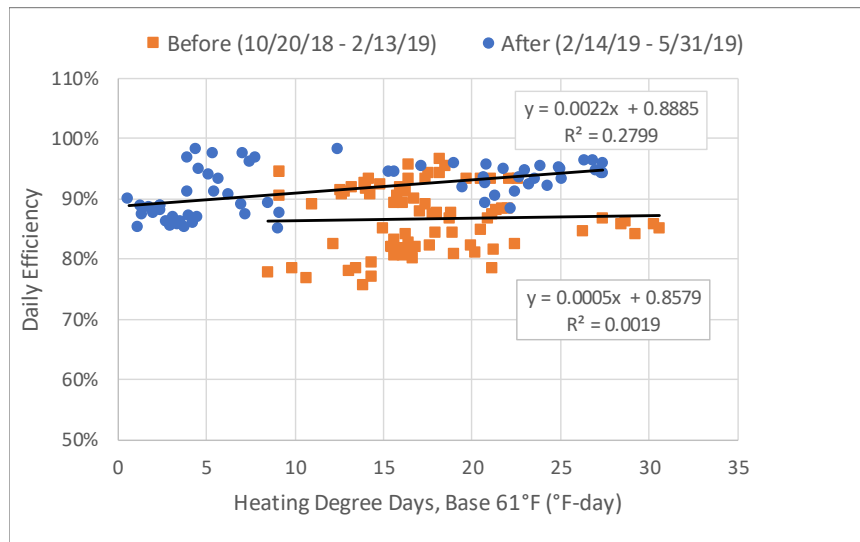
FIGURE 25 - SITE C EFFICIENCY BEFORE AND AFTER BURNER TUNING

For the second ICE Western installation (Site C), we elected up front to bring down their technician to start up the unit; however, they failed to send the HMI tool with the technician. He was still able to make adjustments manually, and the unit seemed to perform well. After a couple months of operation, we noticed that the efficiency of the unit was starting to fall lower than expected (<85%). We made several visits to the site, taking measurements and making small adjustments, but the efficiency remained lower than expected and we discovered that the combustion fan would shake every time the burner was between 40-50% capacity. After several requests, ICE Western sent the HMI tool and we thoroughly tuned the burner on 2/14/2019. Figure 25 shows the Site C daily efficiency before and after this burner tuning.

The total unit efficiency before the tuning was just under 88%; after tuning, the efficiency rose above 94%, as shown in Table 10.

Period	Date Range	Efficiency
Before Burner Tuning	10/20 - 2/13	87.5%
After Burner Tuning	2/14 - 5/31	94.2%
Total Period	10/20 - 5/31	90.5%

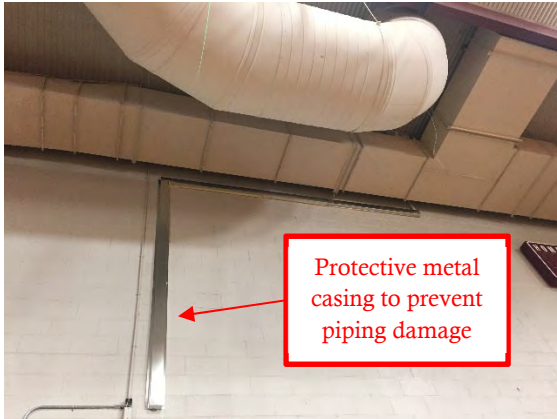
DRAIN PIPING WITH PROTECTIVE CASING

The installing contractor elected to run most of the condensate drain three days before the installation day. The C-RTU is located on the roof of a gymnasium and a scissor lift was required to access the 30-foot ceiling where the drain piping penetrates the roof. The contractor ran 1 ¼" PVC pipe down the gym wall and into a storage room where a small air compressor and floor drain are located. A protective casing was installed over the PVC pipe to prevent damage to the drain piping from gym activities, as shown in Figure 36. Despite the height of the space, this condensate installation was the most straightforward of the four sites and required the fewest labor hours and lowest overall cost to install. In total, the condensate drainage and neutralization system required 29.25 labor hours, \$2,556 in labor costs, and \$148 in materials.
