REPORT #E16-296

## Thermal Break Shear Wall:

A Case Study of Rigid Foam  
Insulation between Frame and  
Sheathing

Miter Construction Management, LLC  
2125 N. Flint Avenue  
Portland, OR 97227

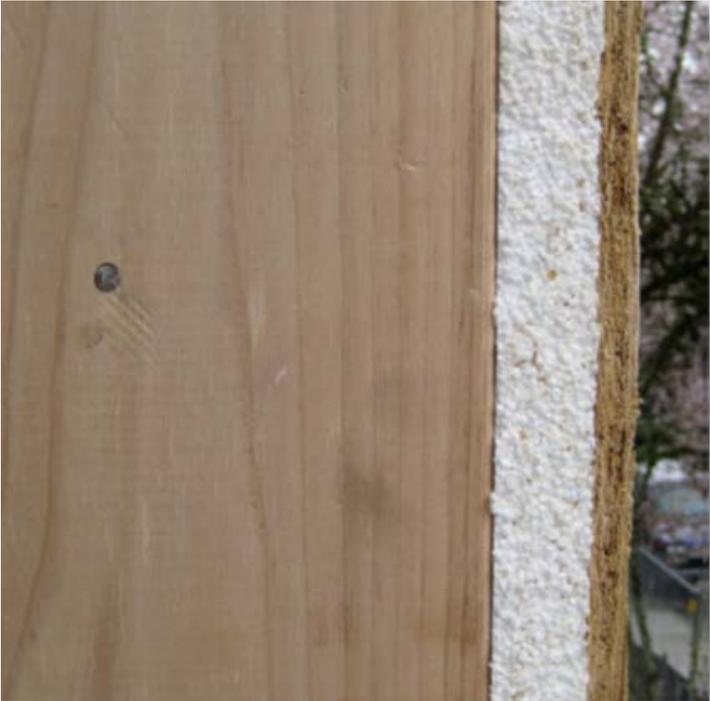
Figures 1 Cross-Section of Wall Assembly

The assembly presented in this report departs from that strategy. In hopes of minimizing production costs, it tasks the framers with installing the foam directly over the wall frame prior to application and attachment of the shear ply. Figure 1 shows a cross-section and construction of the wall assembly.

The project manager wondered whether the foam could go on first, with the sheathing on the outside, which might address a whole host of problems, not least bearing for the windows. Initially the team could not see how framers would nail the foam in place by itself because it is not strong enough to walk on over the wall frame. But maybe they didn't need to walk on it. Maybe they could just tack the corners, put the ply over the top, then walk out and nail both layers off together, one time. Nyseth's calculations said it would work. Framers would have to nail the sheathing every 3" on the perimeter (instead of the standard 6") Field nailing remained at 12".

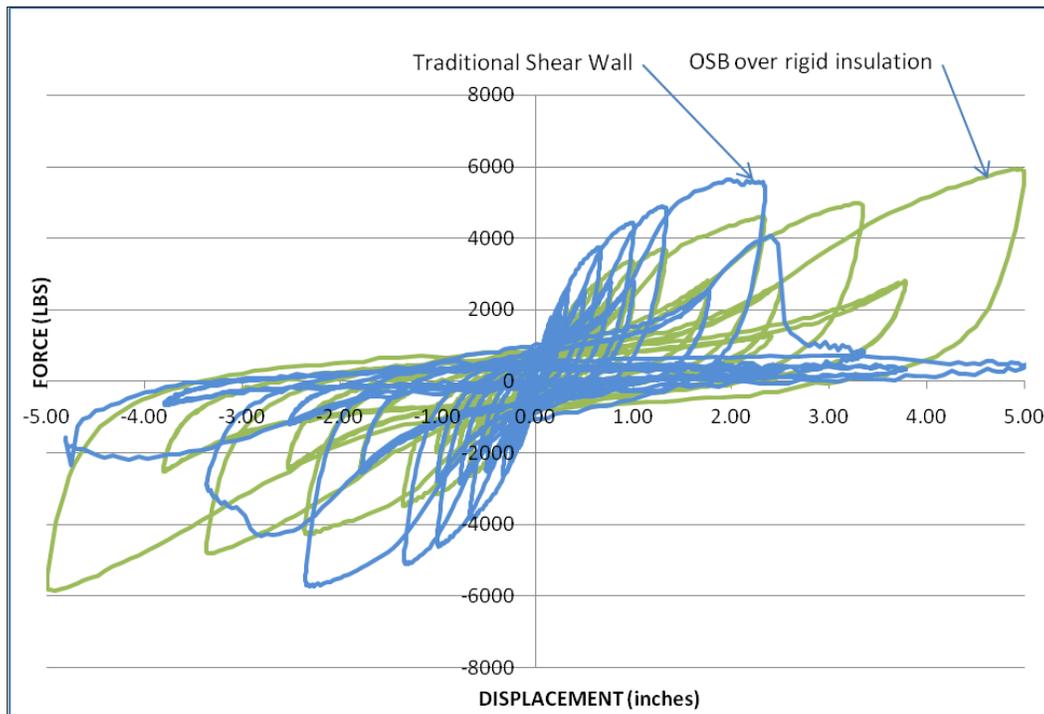
Figure 3. Comparison of Traditional Shear Wall with TBS Wall

“The graph below compares hysteresis loops, force curves, from the tests of a conventional wall, and a [TBS] wall. The curves describe wall panels bolted into a test rack, being pushed and pulled increasingly out-of-square by a test cylinder. The blue line shows a conventional assembly reaching its capacity at about 1-3/4” of deflection, under a 5,600-lb load, and suffering catastrophic failure. The green line shows a [TBS] wall continuing to resist deflection with increasing strength as the test reaches its protocol maximum deflection of 5”.”

Much to everyone’s surprise, The increased flexibility of this wall assembly delivered a higher lateral load capacity than does a conventional wall assembly, and also made the wall much more resilient in the face of the racking motion typical of seismic events.

The cyclic load tests revealed something that prior static load investigations, such as those discussed in APA<sup>5</sup> Tech Bulletin C456E, had not. Putting the foam between the frame and shear ply had shifted the controlling characteristic of the shear nails. Conventional walls, with plywood nailed tight to the frame, fail under the cyclic lateral loading of the test when the shear strength of the nails overpowers the integrity of the plywood. The nails, embedded in the dimensional frame, tear the edges and corners off the plywood sheets and the assembly disintegrates, separating the shear panel from the wall frame.

Putting the foam between the frame and sheathing shifts the controlling characteristic of the nails. Their strength in bending takes the place of their shear strength as the controlling characteristic of the assembly. The bending dissipates energy, increases the flexibility of the assembly, and protects the assembly against destruction of the plywood by the nails. The dynamic cyclic testing revealed improvements so large that the capacity of the wall assembly lies somewhere beyond the bounds of the destructive test protocol underlying the commercial building code. Figure 2 shows the forces applied to both a conventional light frame wall assembly and to the thermal break wall assembly.

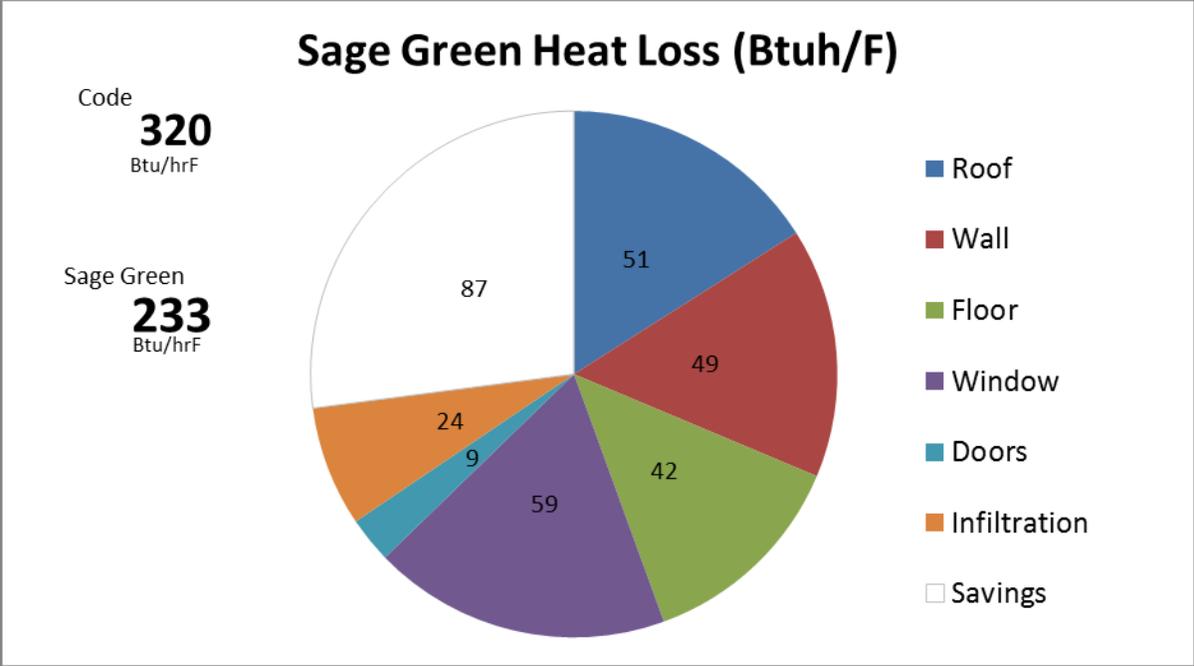
**FIGURE 4. DESIGN HEAT LOSS SAGE GREEN HOMES**

effective R16.7 value, this wall system has an effective R28.1 value (effective). Sage Green project also facilitated achievements of a continuous air barrier and an air exchange rate of 2.1 ACH50. These achievements, combined with triple-glazed low-e windows upgraded from the code minimum of 0.35 Btu/hr-ft<sup>2</sup>-°F to 0.26 Btu/hr-ft<sup>2</sup>-°F, would result in a twenty-seven percent decrease in the annual design load of one of the Sage Green homes (see Figure 3). This improves comfort and enables a smaller-sized mechanical system for an incremental cost of about \$2,000. The occupants of such a home would save roughly \$5,000 in heating costs over the first thirty years, assuming energy costs remained constant.
